Post-Construction Project Report of the Larimer County Road 43 River Restoration

North Fork of the Big Thompson River

U.S. Department of Transportation

Federal Highway Administration

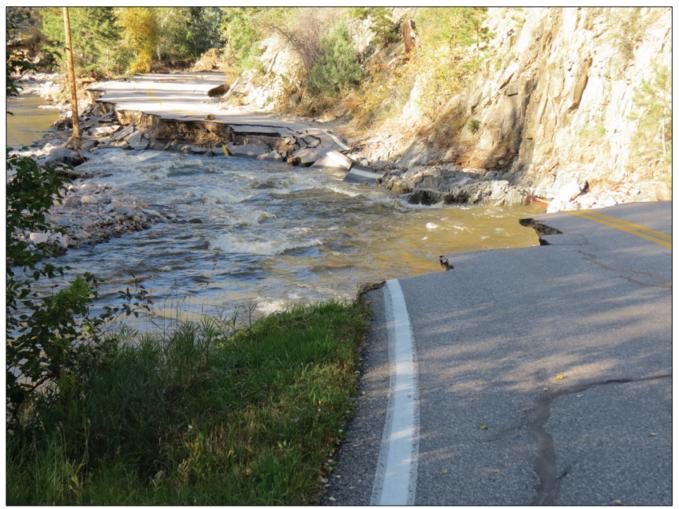
In September 2013, significant rainfall along the Front Range of the Colorado Rocky Mountains resulted in the worst flooding seen in these areas in more than 30 years. These floods caused significant damage to the roadway system that links the western regions of Boulder and Larimer counties to the populated plains cities, and many of these mountain communities were isolated for more than a week. Larimer County Road 43—a major thoroughfare between the Glen Haven and Drake—was one of these impacted corridors (Figure 1).

Figure 1. Example of road damage as a result of the 2013 flood

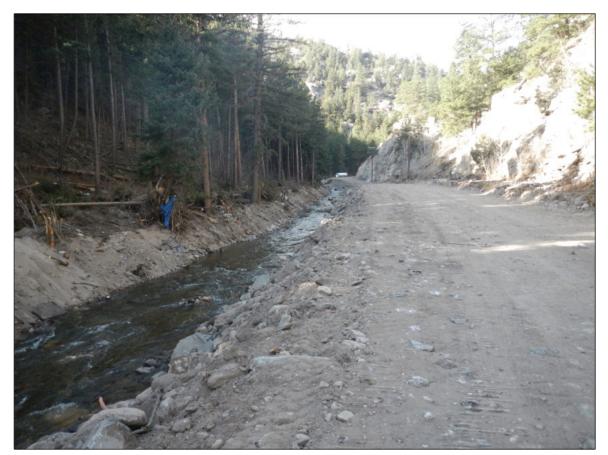
The resulting post-flood streams were eventually re-channelized into their pre-flood alignment by Larimer County and private contractors hired to provide temporary emergency access. Newly scoured bends and areas of lateral migration were filled during this process and the stream beds were left in a raw and unstable condition. Following the bridge construction and preliminary road alignments (beginning in November 2015), the Stream Recovery Team was provided with materials and equipment to implement stream channel restoration (Fig. 3).

Figure 3. Channelized creek following CR 43 reconstruction and prior to stream restoration.

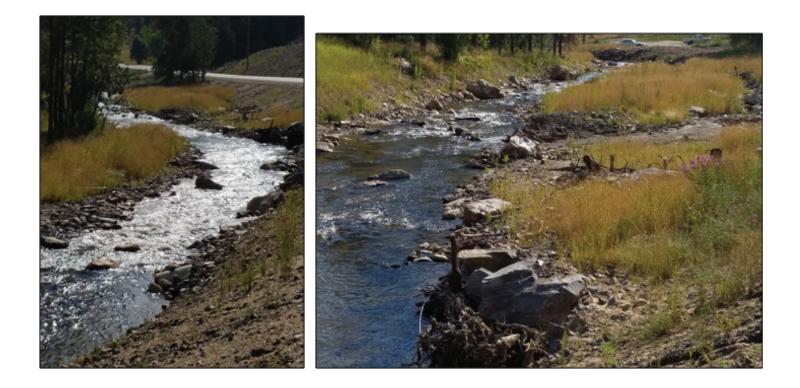
Dunraven bridge is a Larimer County bridge that survived the flood. The County repaired scouring along the abutment walls and the compound channel constructed both above and below the bridge continued through it. This reach of the West Seed project was completed first in the Fall of 2015 and allowed Wildland Restoration Volunteers (WRV) to come in and do riparian plantings and seeding. This was all paid for by private grants obtained by WRV. Treatments in this reach included root wad revetment, boulder clusters, riffle-pool sequencing, floodplain benching and expanded capacity.

Figure 24-Riparian regeneration after one season of growth near the Dunraven Bridge
