Post-Construction Project Report of the Larimer County Road 43 River Restoration

North Fork of the Big Thompson River

U.S. Department of Transportation

Federal Highway Administration

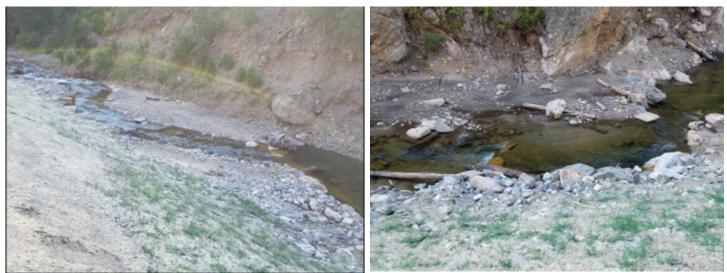
terraces. Additional rock and large woody debris was installed to enhance the aquatic habitat.

Figure 14-Post construction upstream of Bridge 3 on left and downstream on right

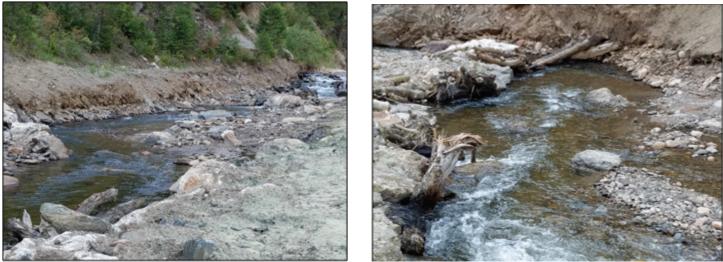
Figure 15-constructed step-pools on left and root wad revetment with habitat wood on right upstream of bridge

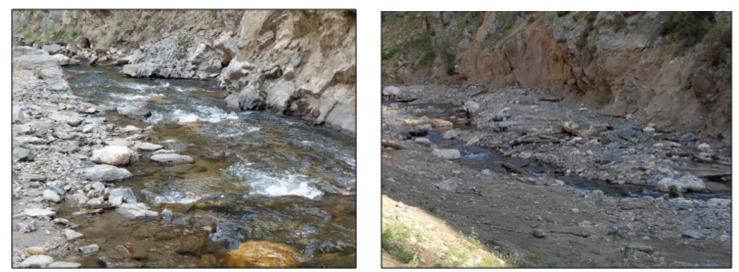
Figure 16-Riffle-pool sequencing and expanded floodplain bench above bridge on left and downstream of bridge on right

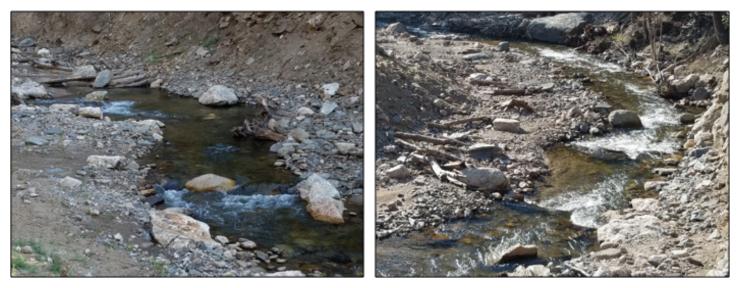
Figure 17-Expanded floodplain capacity upstream and downstream of Bridge 5

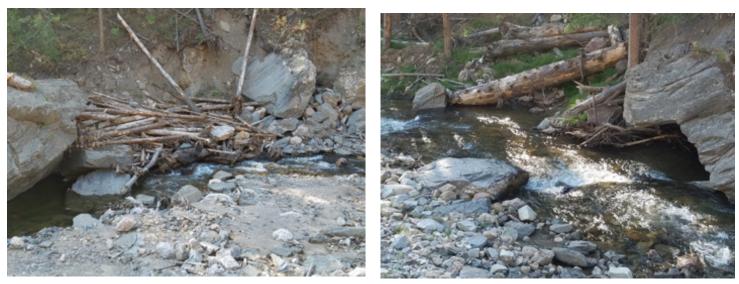
Figure 18-Constructed log jam and enhanced aquatic habitat downstream of Bridge 5

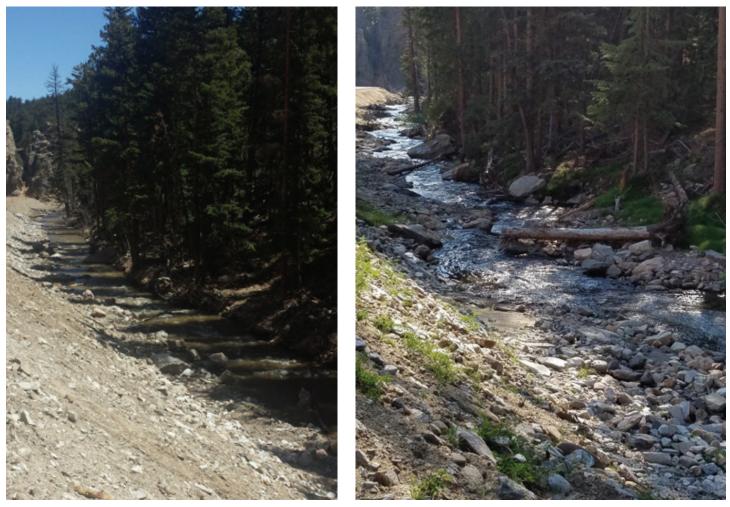
Figure 19-Long confined reach downstream of Bridge 5 before and after construction

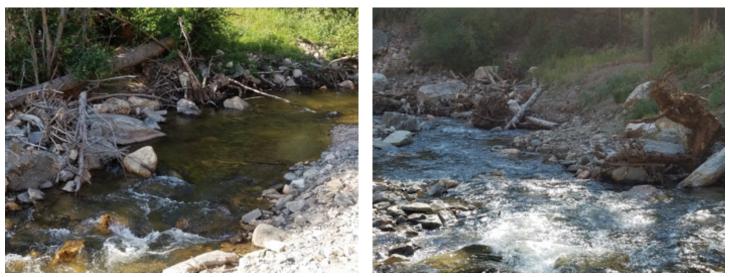
Figure 20-Pool habitat upstream of tributary & root wad revetments downstream

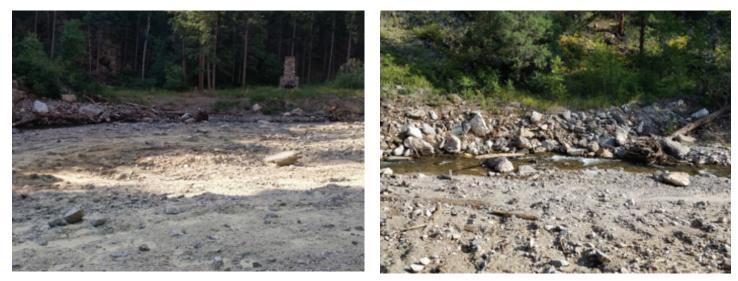
Figure 21-Expanded floodplain benches up and downstream of Bridge 6

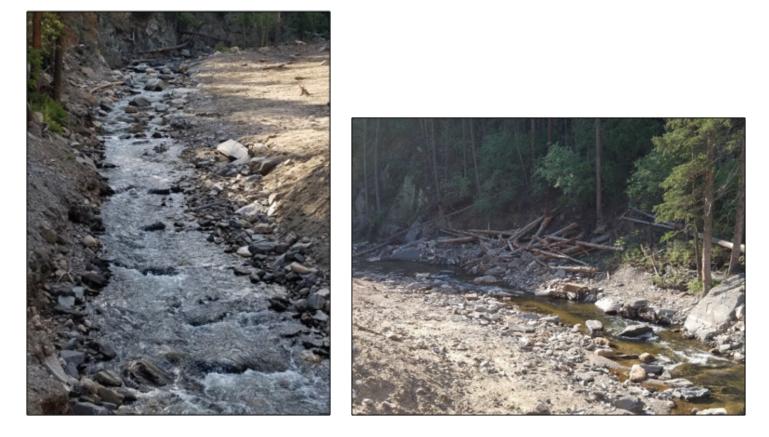
Both upstream and downstream of Bridge 7 there has been significant floodplain excavation with large amounts of woody material anchored both on the benches and in the channel. This is another location where the road and the river alignments have been flipped to increase resiliency.

Figure 22-Expanded floodplains, boulder clusters, constructed large woody debris up and downstream of Bridge 7

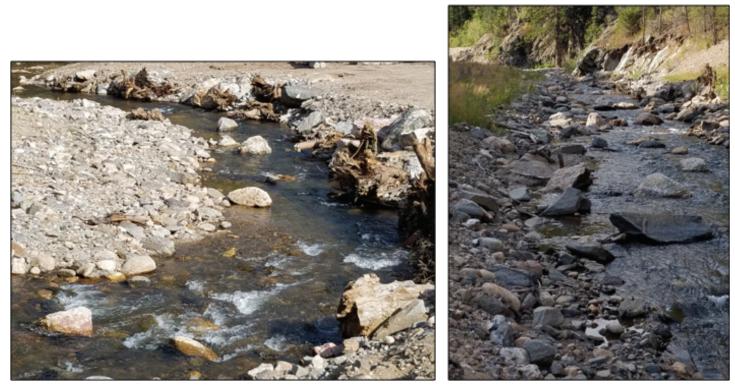
Figure 23-Root wad revetment at horseshoe bend & channel downstream of Bridge 8

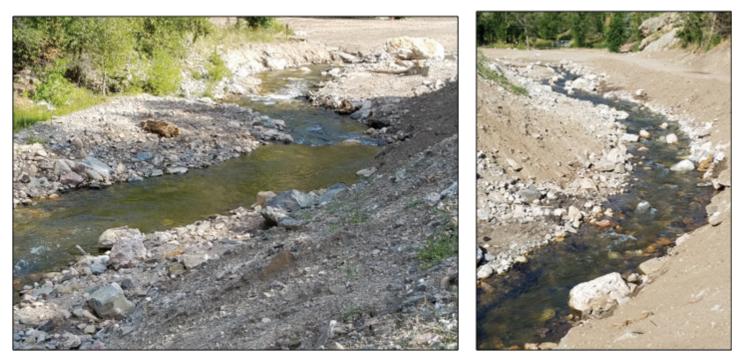
Figure 25-Meandering riffle-pool complex using primarily boulders at Ballard site

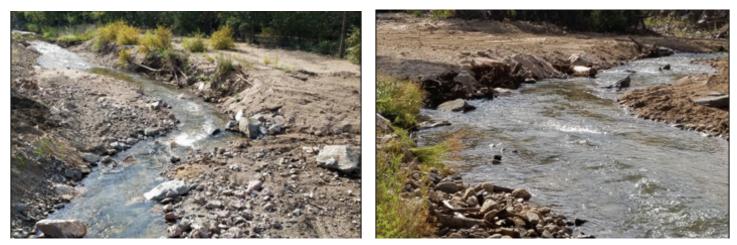
The site downstream of Bridge 11 was used by the contractor for staging. The channel in that area had been ditched and straightened. The downstream landowner, Wilder, had requested that it be put back into the pre-flood alignment that took it further away from his residence. Treatments at this reach included Boulder and root wad revetments, channel realignment and riffle-pool sequencing throughout the 800-foot reach.

Figure 26-Channel meandering, root wad revetment and boulder clusters downstream of Bridge 11

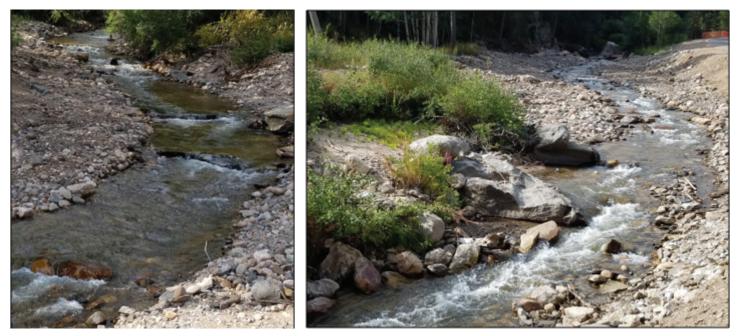
Figure 27-Floodplain grading and boulder placement at Whiteside

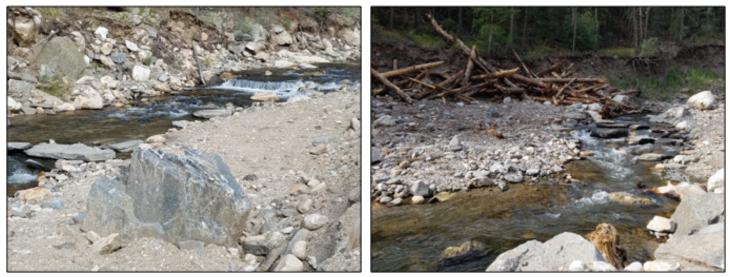
Figure 28-Strategic rock placement for riffle-pool morphology & log jam on expanded floodplain

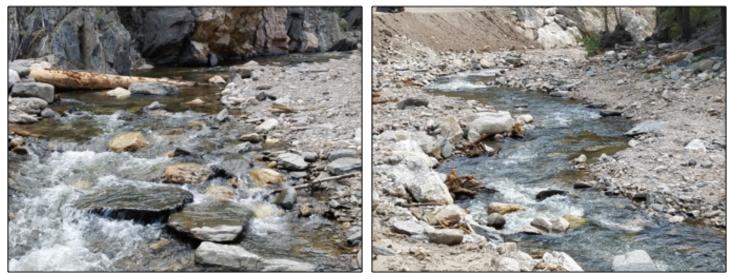
Figure 29-Deep constructed pools alongside bedrock with log enhancement & expanded floodplain

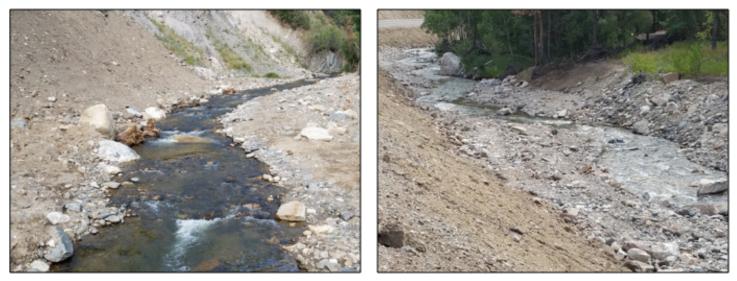
Figure 30-Expanded floodplain benches, root wad installation, meandering channel, riffle-pool sequencing

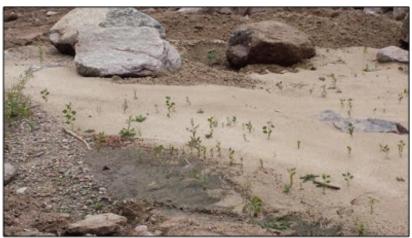
Figure 33. Floods are regenerative and vegetation will slowly establish; however, jump-starting the process with native plantings and seeding will help suppress weeds and invasive species while encouraging soil and sediment cohesiveness immediately after construction.

Revegetation should be conducted or planned in conjunction with channel work (Figure 33). Native vegetation can have specific topographic and final grade requirements that are necessary for the plants to root and thrive. These considerations are best addressed in the design phase of the project. Immediate coordination with native vegetation experts such as the US Forest Service, CWCB-supported Native Riparian Plant Propagation Program and/or volunteer groups such as Wildlands Restoration Volunteers and the Conservation Corps to improve native revegetation and reduce the need for post-construction weed control is recommended. Additionally, cooperation with
